USAF MISHAP REPORT

1. DATE OF OCCURRENCE (Day, Month and Year) 18 April 1986		2. VEHICLE(S) OR MATERIEL INVOLVED (Model designation and serial no. if applicable) Titan 34D-9		3. FOR GROUND ACCIDENTS ONLY (Base Code and Report Serial No.) 86-4-18-701

8. (List organizations of second vehicle, if they differ from item 7 above)						
9. ORGANIZATION AND BASE SUBMITTING REPORT (Do not abbreviate) Titan 34D-9, Class A Space Mishap Investigation Board, HQ Air Force Systems Command, Andrews AFB, MD 20334

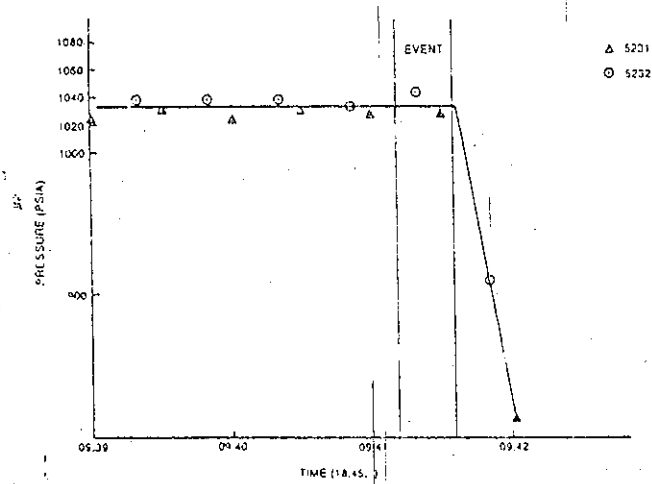
Figure 2.3-3 SRM-2 Manifold Pressure

109.4141- 109.4164		8.7641 -2.5/+0 8.7646 -1/+0		STG 1 Vert Accel (2305) Disturbance	TM	-0.30 pitch
109.4129- 109.4179		8.7629 -5/+0 8.7629 -1/+0		SEM2 Injectant Manifold Press #2 (5232) Decreases	TM	Pressure drops from 1050 to 918 PSIA

109.4148- 109.4198		8.7648 -5/+0 8.7798 -1/+0		SEM2 Injectant Manifold Press #1 (5231) Decreases	TM	Pressure drops from 1032 to 818 PSIA
109.4178- 109.4203		8.7678 -2.5/+0 8.7703 -1/+0		Fuel Suction Pressure (775-1) Drops (1515)	TM	Fuel Pressure drops from 49.8 to 31.8 PSIA

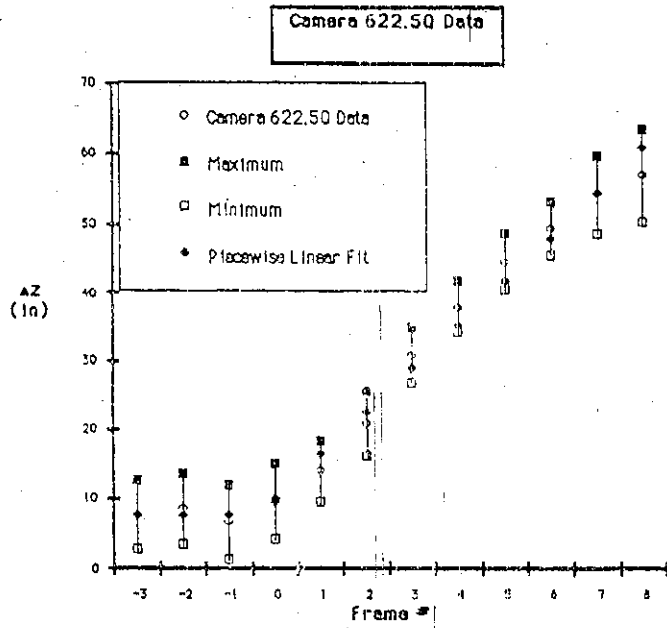
SRM-2 Nose Motion History

109.498		8.848		SEM2 approx. early move	File	Physical breakup begins (3)
109.644- 109.708		8.984- 9.058		SEM1 movement	File	
109.477- 109.787		9.027- 9.137		STG1 Ox Cloud appears	File	STG1 Ox tank ruptured

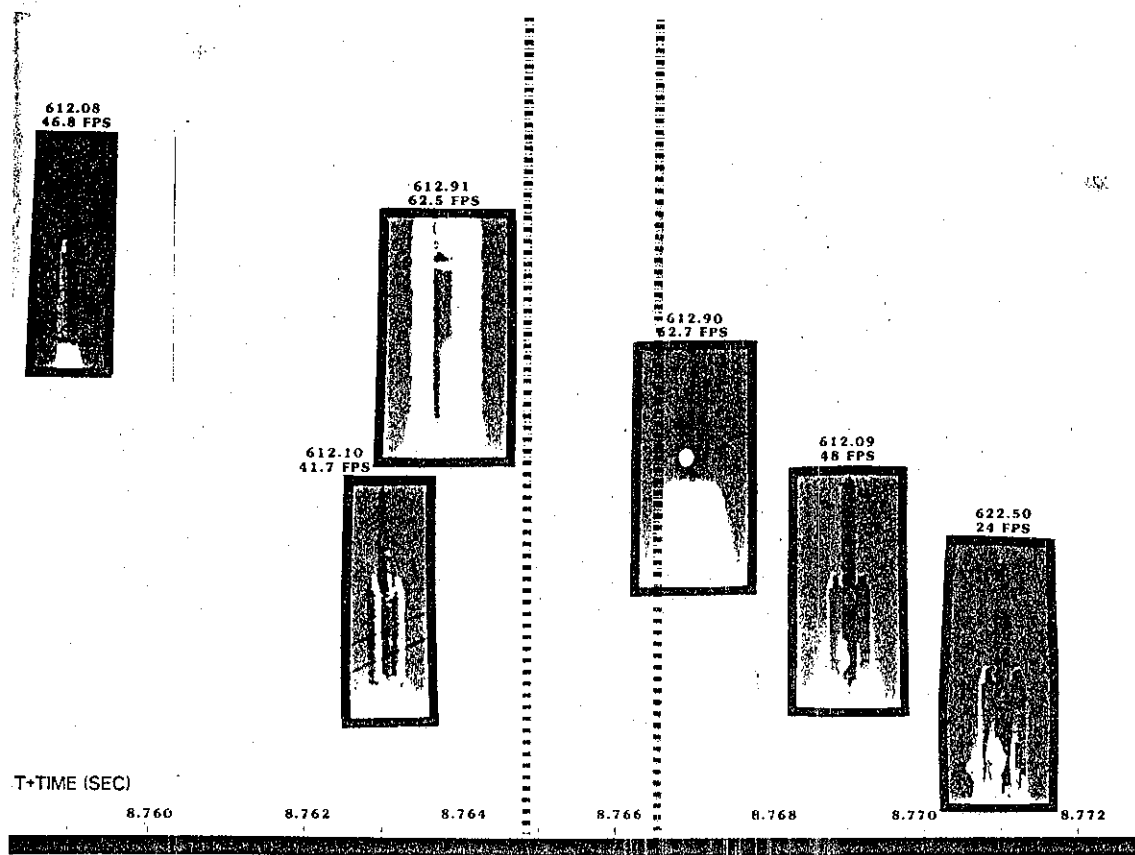
SRM 2 TVC MANIFOLD RUPTURED

STAGE 1 FUEL TANK RUPTURED

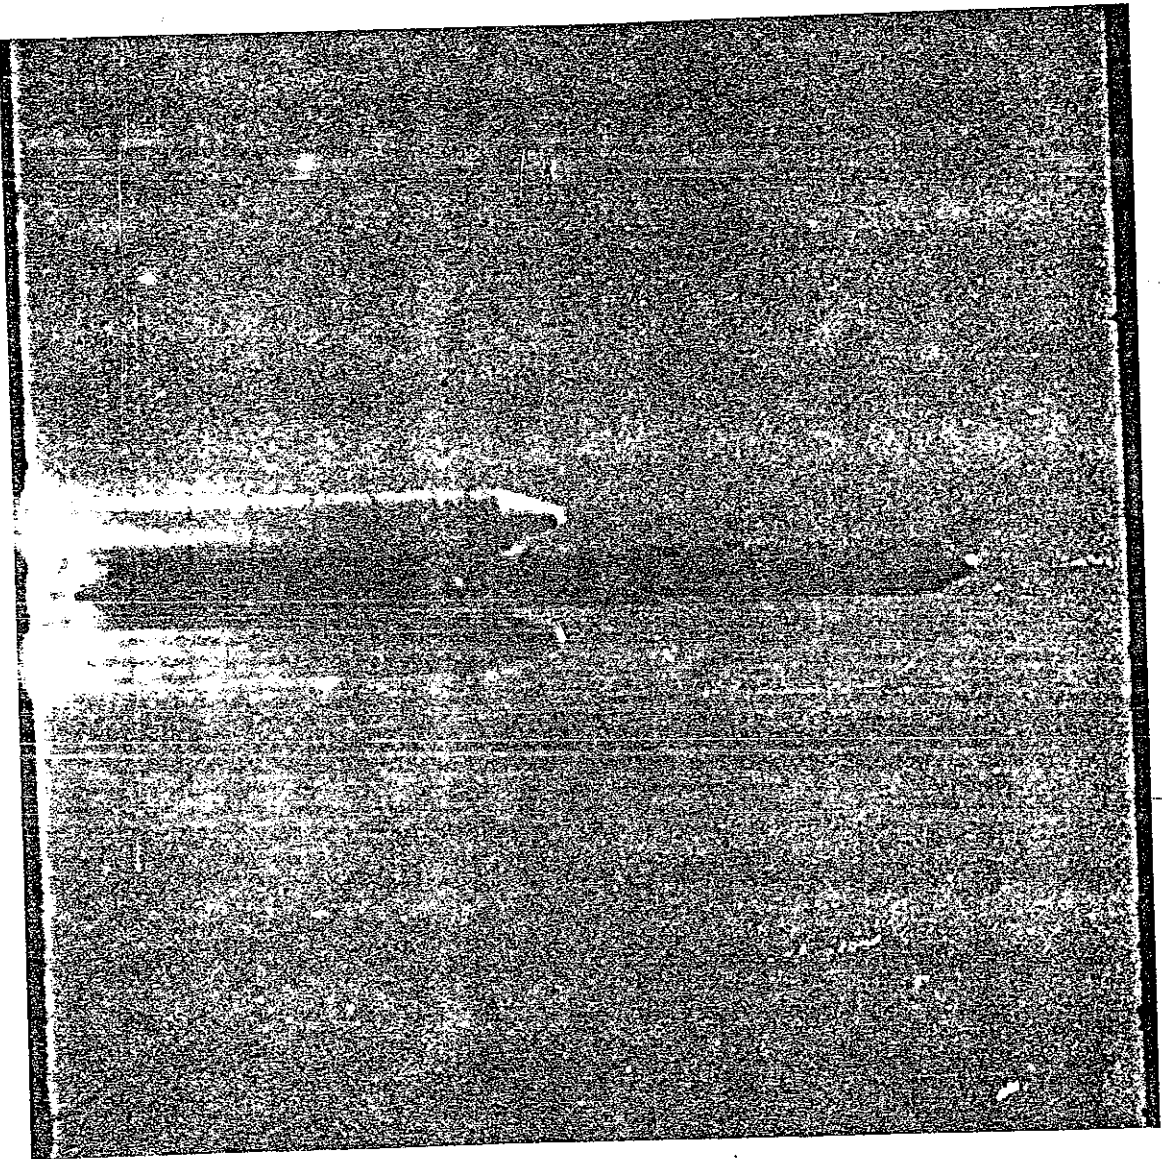
One Frame Prior to Event
T+8.729 Seconds
(Film 622.50, Frame -1).

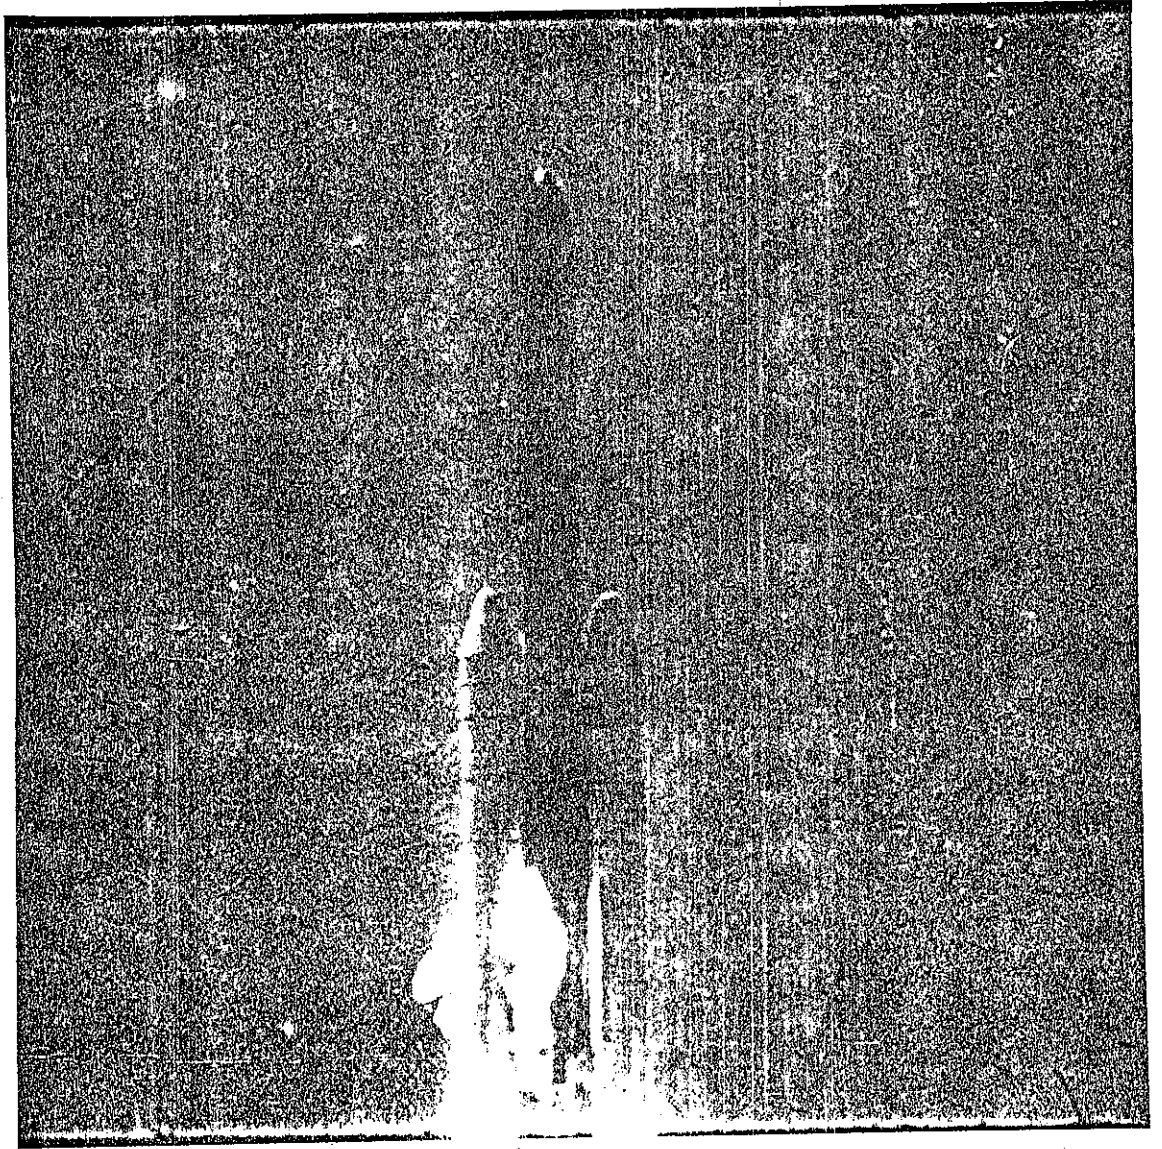
First Frame Showing Event
T+8.771 Seconds
(Film 622.50, Frame 0)

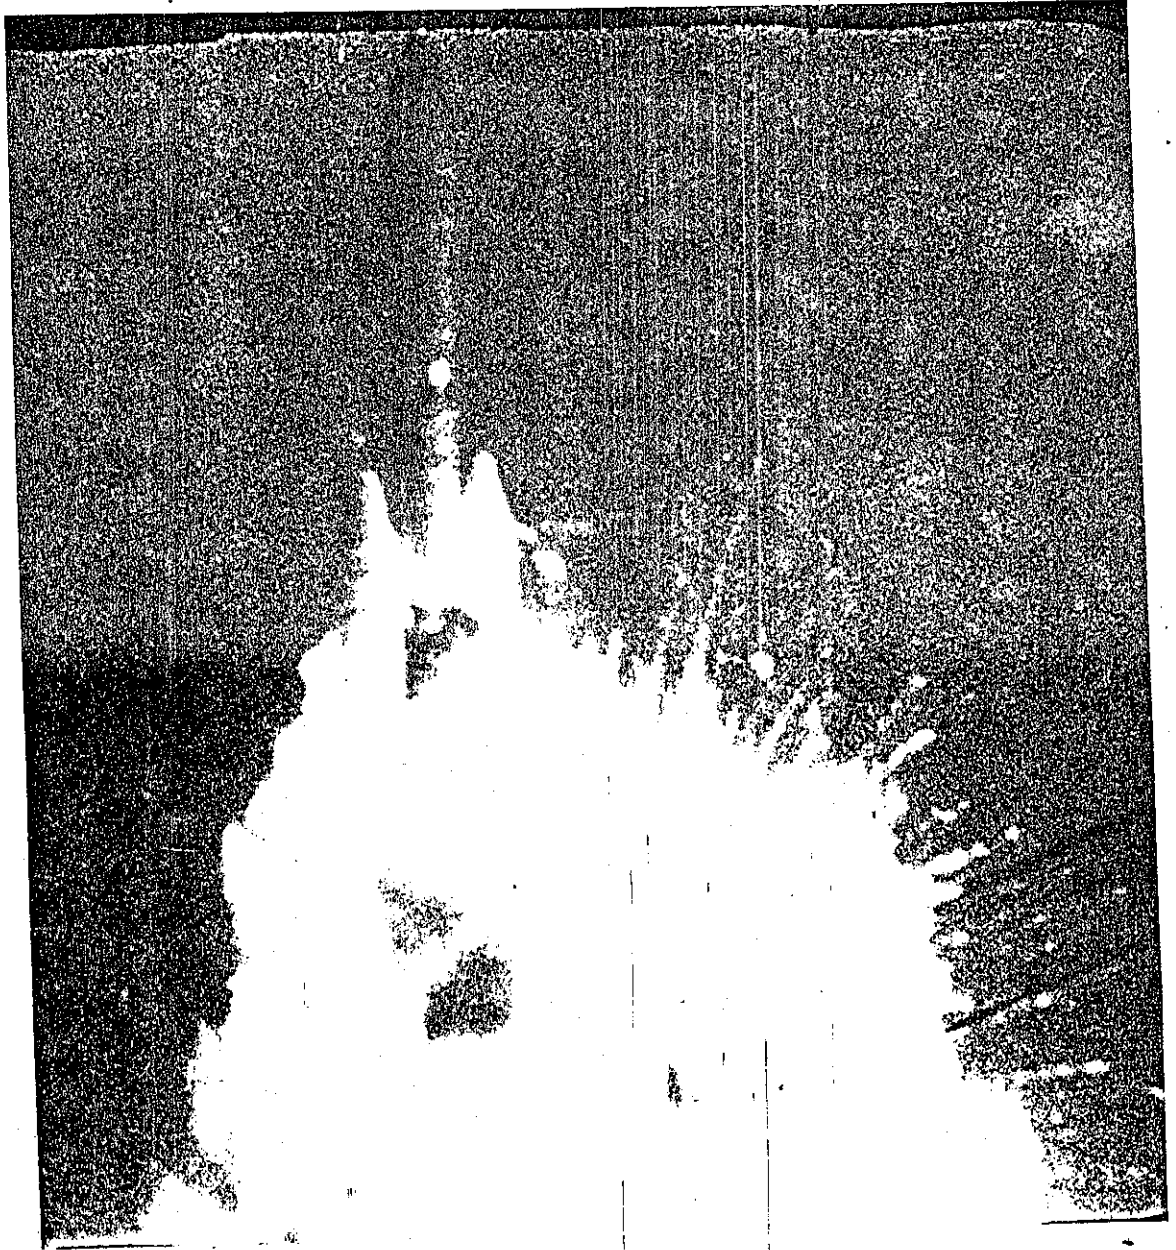
SRM-1, ISDS Destruct (612.10 Fm +13)

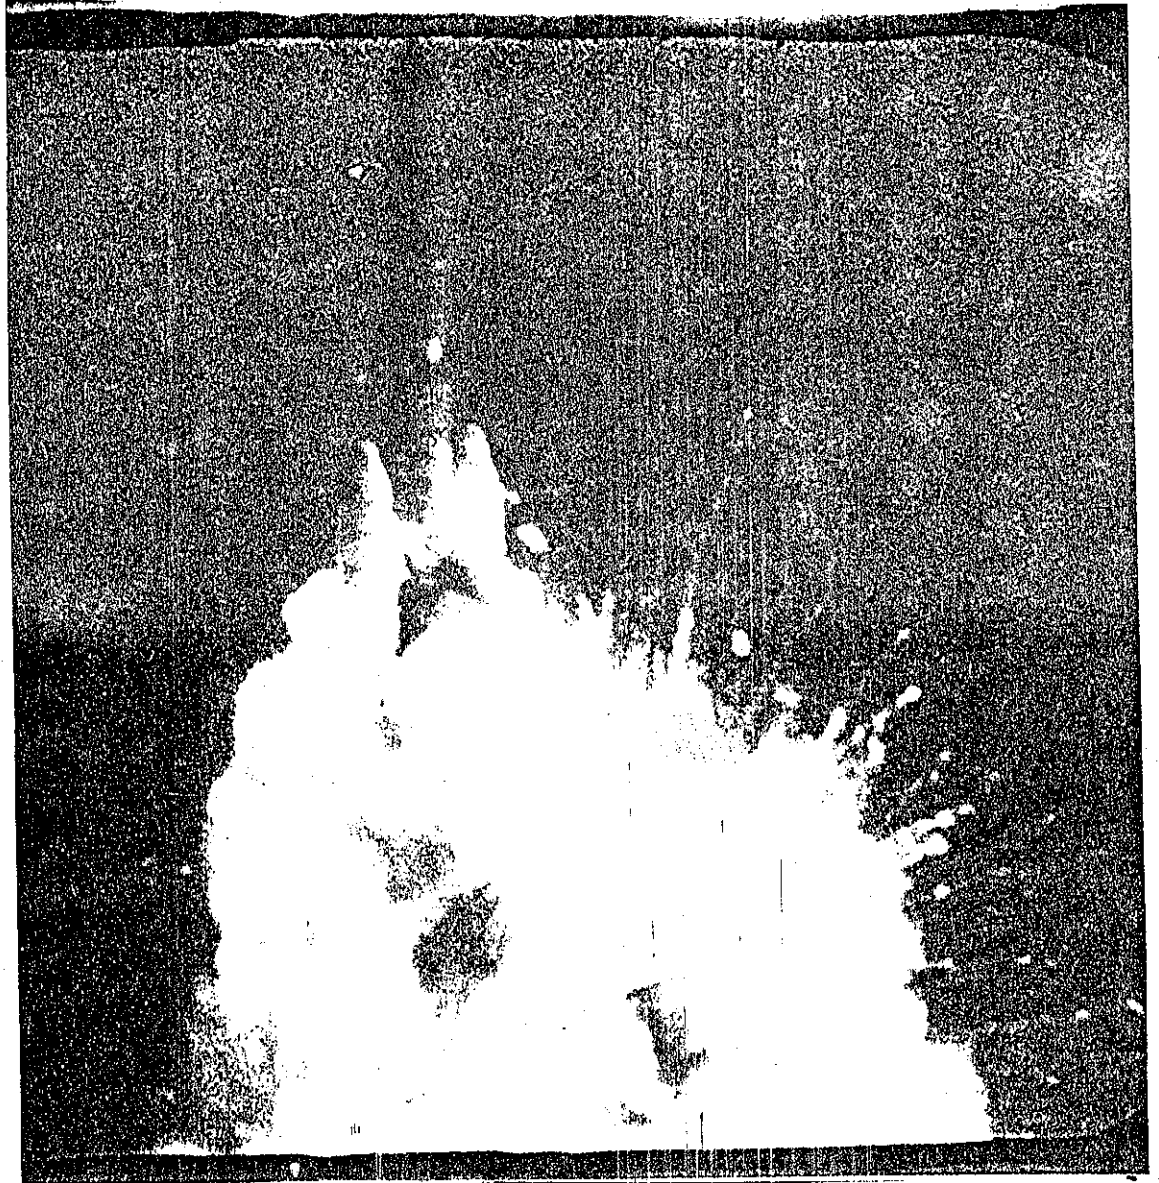
SRM-1, ISDS Destruct (612.10 Fm +14)

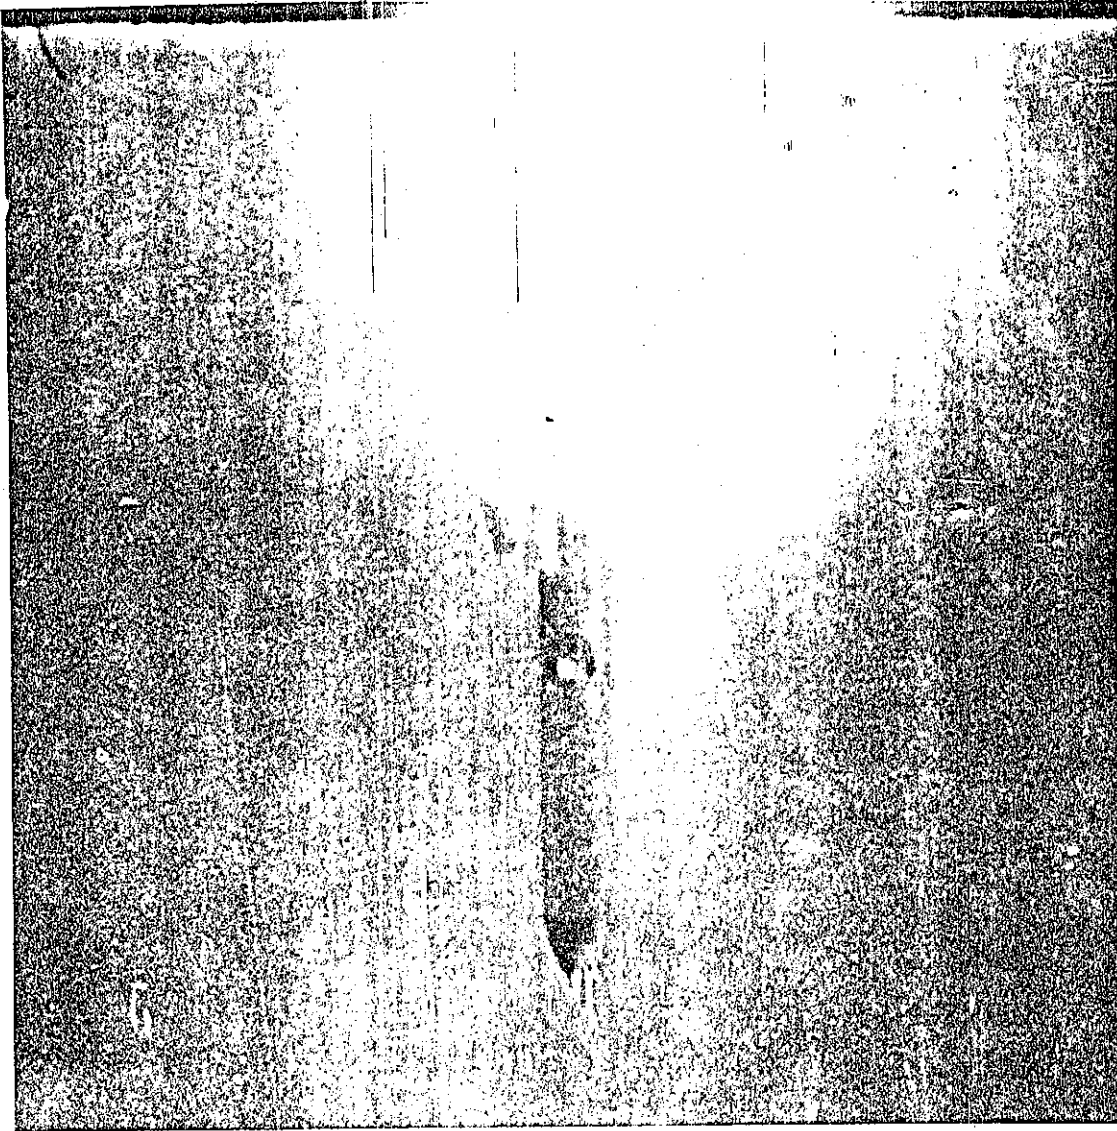
Fireball Expanding
1+8.812 Seconds
(Film 622.50, Frame +1)

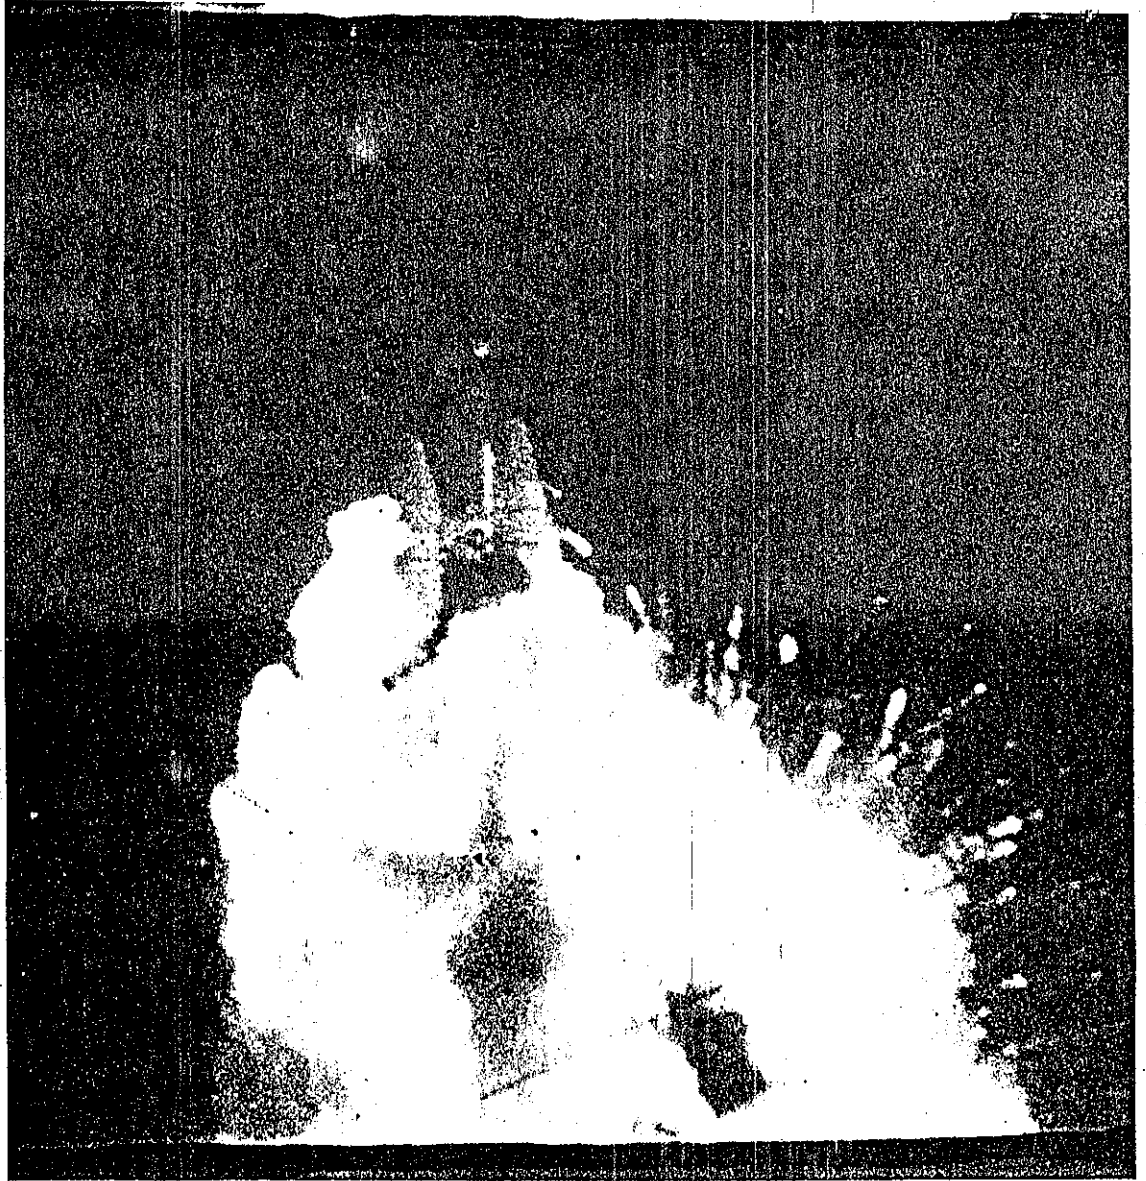
SRM-1, ISDS Destruct (612.10 Fm +15)

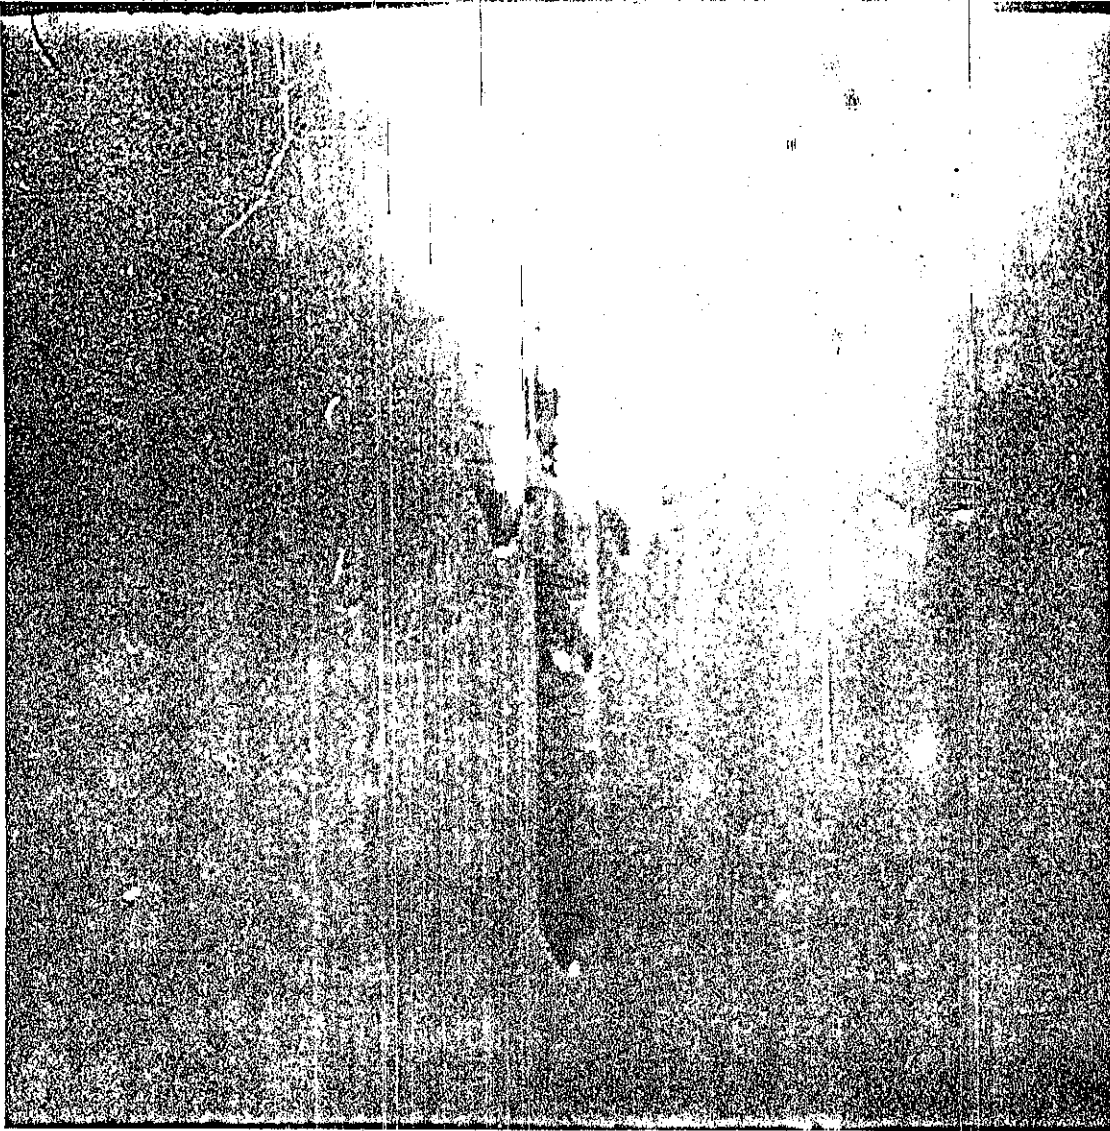
Fireball Expanding
1+8.854 Seconds
(Film 622.50, Frame +2)

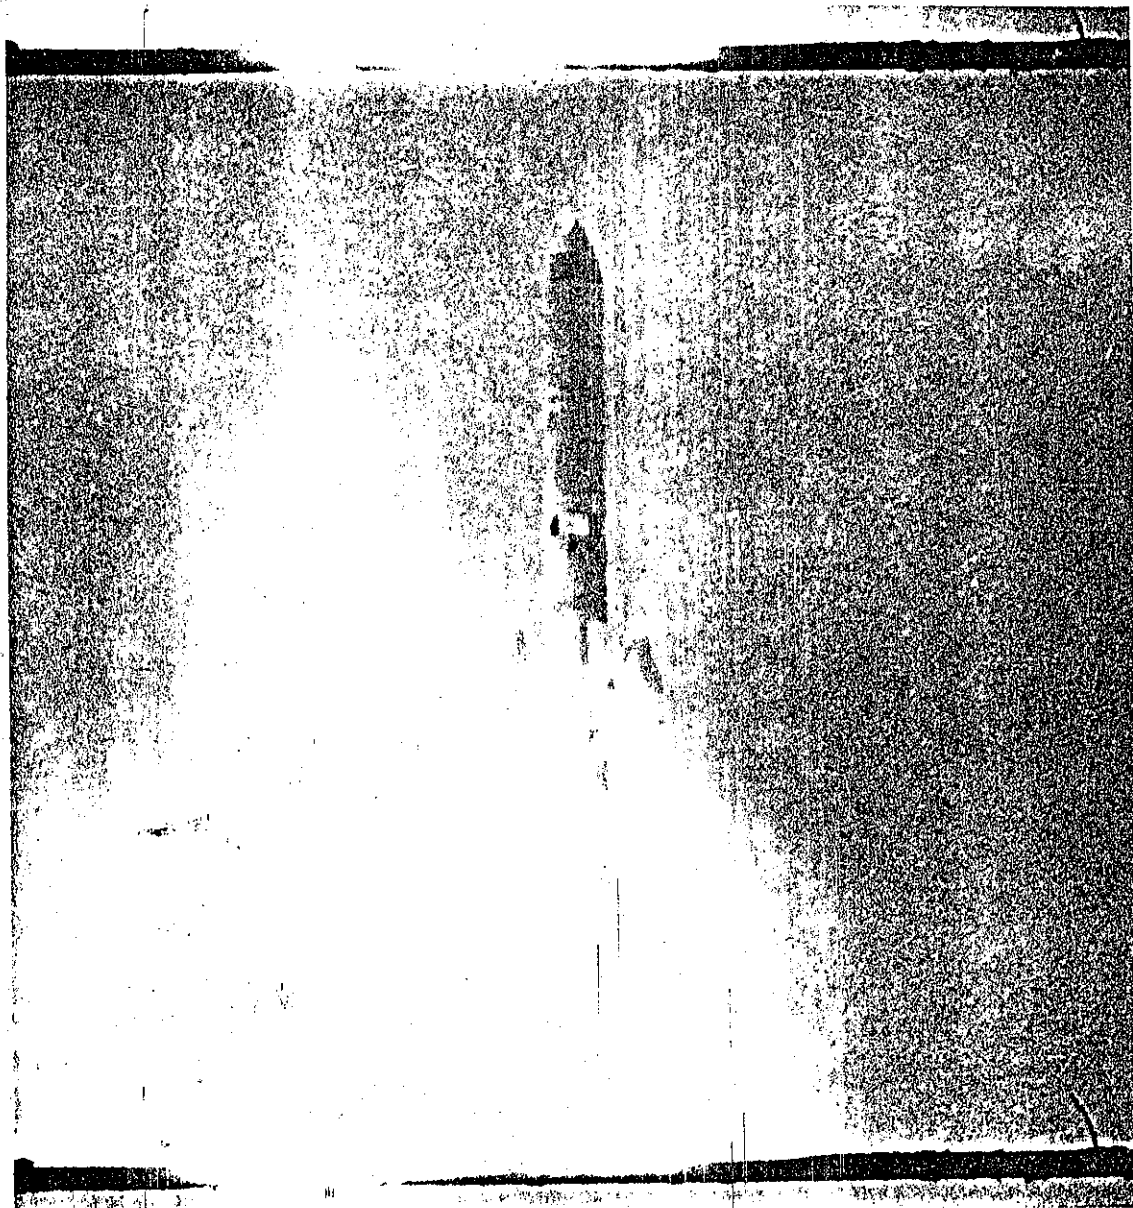
SRM-2 Motion (622.50, Fm +2)
