USAF MISHAP REPORT

1. DATE OF OCCURRENCE (Day, Month and Year) 18 April 1986		2. VEHICLE(S) OR MATERIEL INVOLVED (Model designation and serial no. if applicable) Titan 34D-9		3. FOR GROUND ACCIDENTS ONLY (Base Code and Report Serial No.) 86-4-18-701

8. (List organizations of second vehicle, if they differ from item 7 above)						
9. ORGANIZATION AND BASE SUBMITTING REPORT (Do not abbreviate) Titan 34D-9, Class A Space Mishap Investigation Board, HQ Air Force Systems Command, Andrews AFB, MD 20334

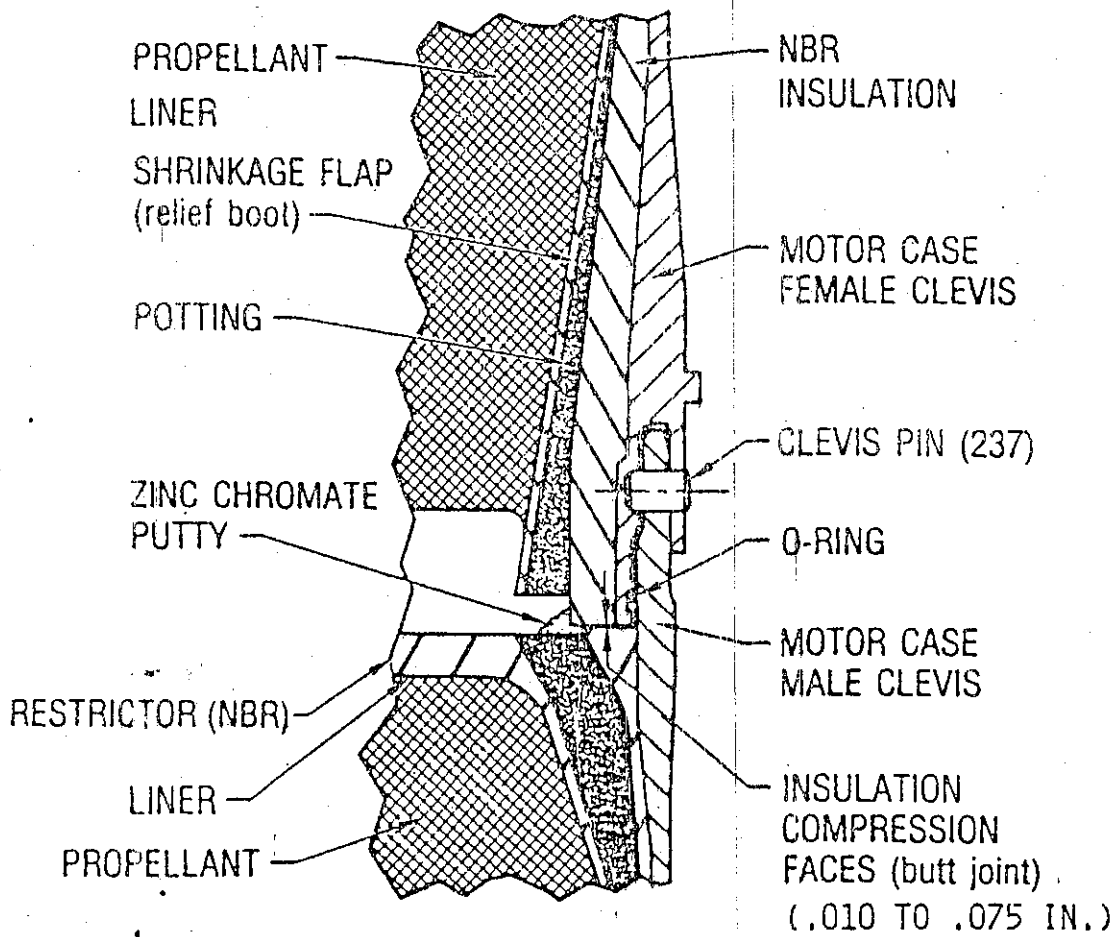
SRM Segment-to-Segment Interface

2.1.1.4 The segments and closures are joined by a pin and clevis type joint (Figure 2.1.1.2-1), each held together by 240 cylindrical pins which are inserted by hand and held in place by a retaining strap. A gas pressure seal is provided by an insulator compression joint sealed with zinc chromate putty and a back-up O-ring in the segment joint.

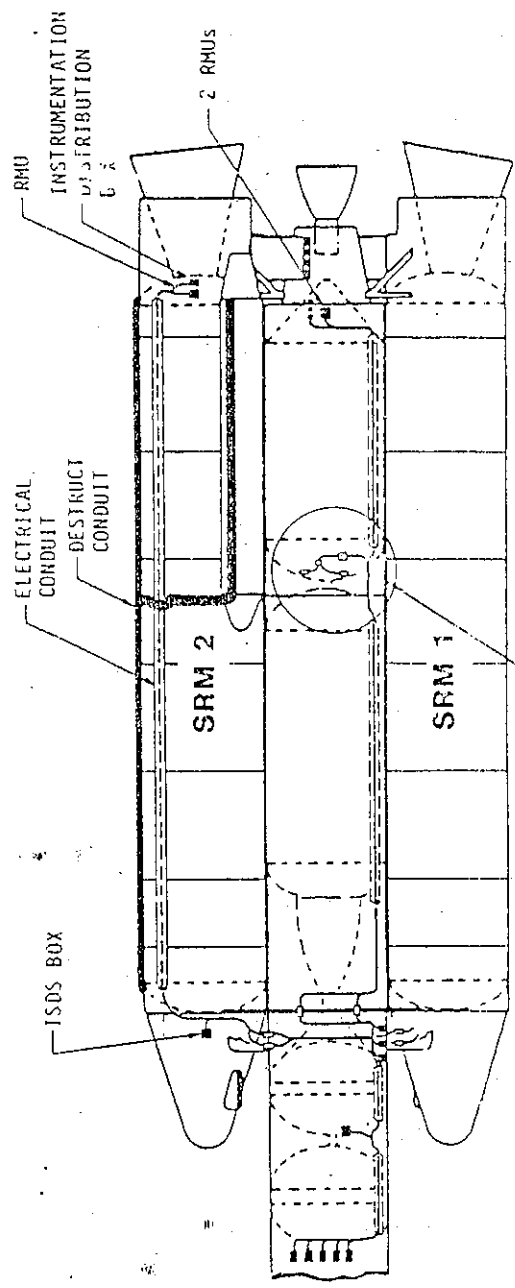
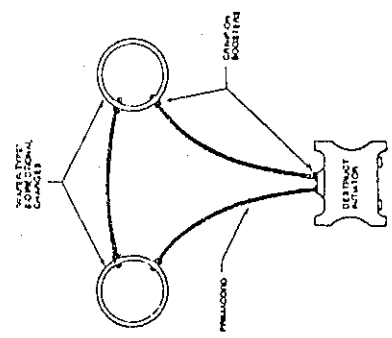
T34D Destruct System

2.1.4.2 The SRM ISDS is a "hot-wire" activated, electronic system that requires the loss (breaking) of redundant hot wires and safety ground wires between the SRM and the core vehicle prior to activation. The destruct system consists of a linear shaped charge that splits each metal case segment down its length, jumpers to conduct the shock wave across segment interfaces, a linear shaped charge to split the thrust vector control (TVC) tanks, and a jumper to connect the main SRM charge to the TVC tank (Figure 2.1.4-1). The primary function of the SRM ISDS is to activate destruct in the event that the command link is lost due to premature separation of the SRM from the core vehicle. The ISDS is disabled prior to normal separation of the SRMs on command from the core vehicle.

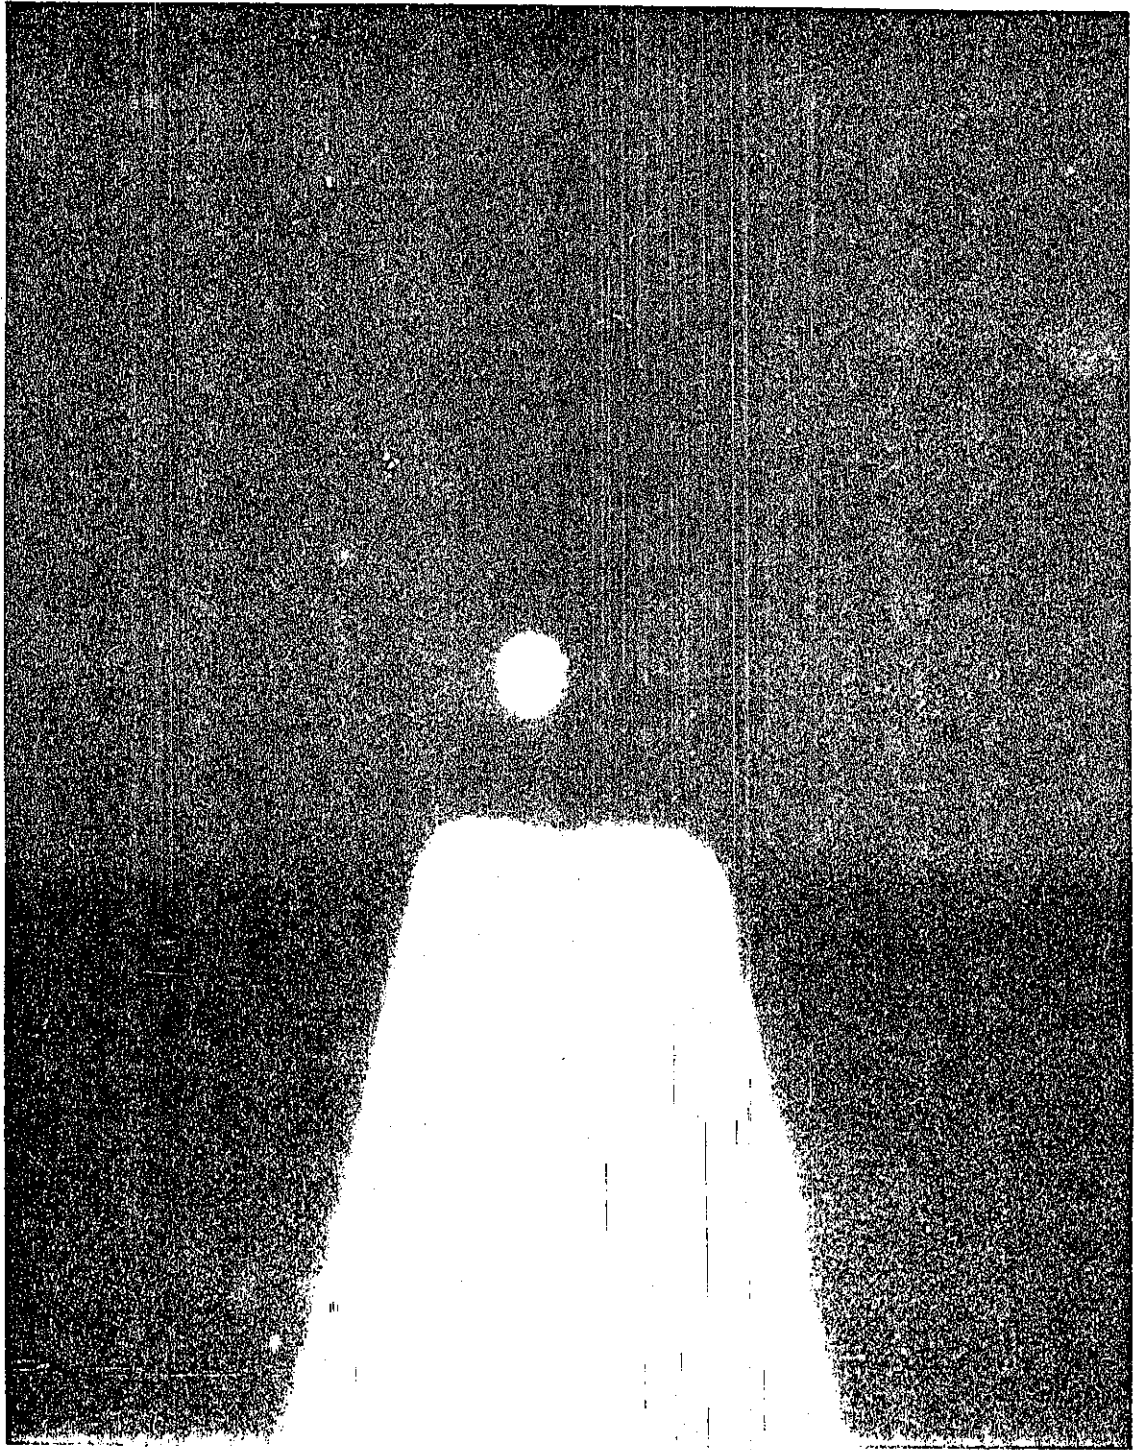
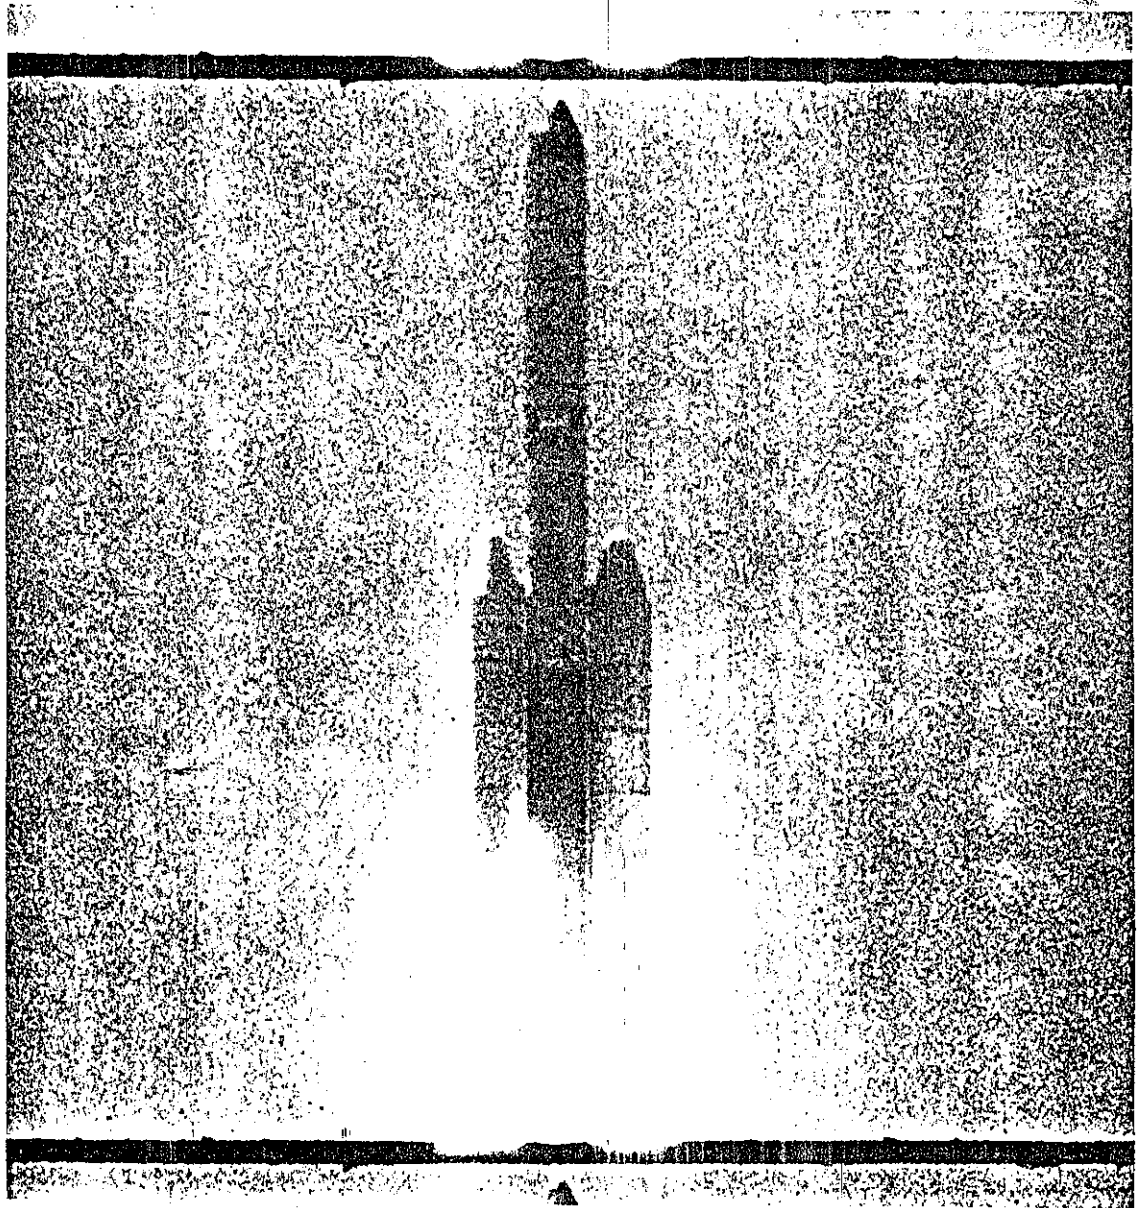
First Frame Showing Event
T+8.771 Seconds
(Film 622.50, Frame 0)

SRM 2 TVC MANIFOLD RUPTURED

STAGE 1 FUEL TANK RUPTURED
